CONNECTICUT RIVER BASIN
WINCHENDON, MASSACHUSETTS

HUNTS POND DAM
MA 00634

PHASE I INSPECTION REPORT NATIONAL DAM INSPECTION PROGRAM

DECEMBER 1979

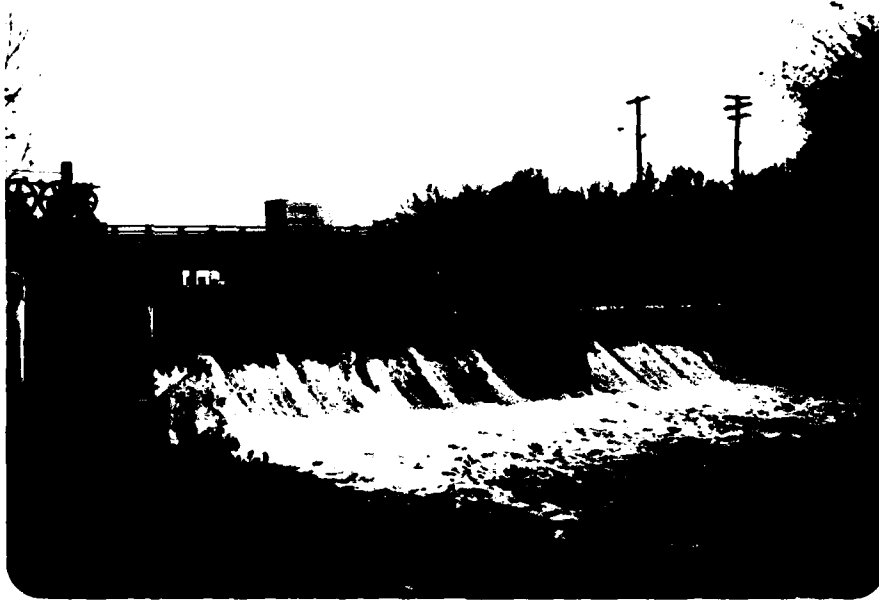
NO. 1 DOWNSTREAM FACE OF DAM

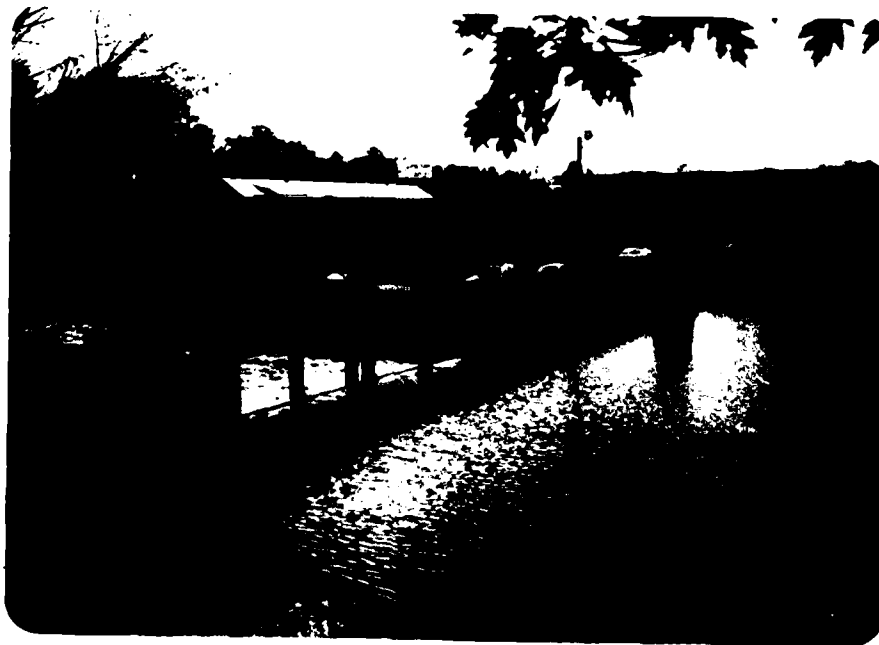
NO. 2 UPSTREAM FACE OF DAM

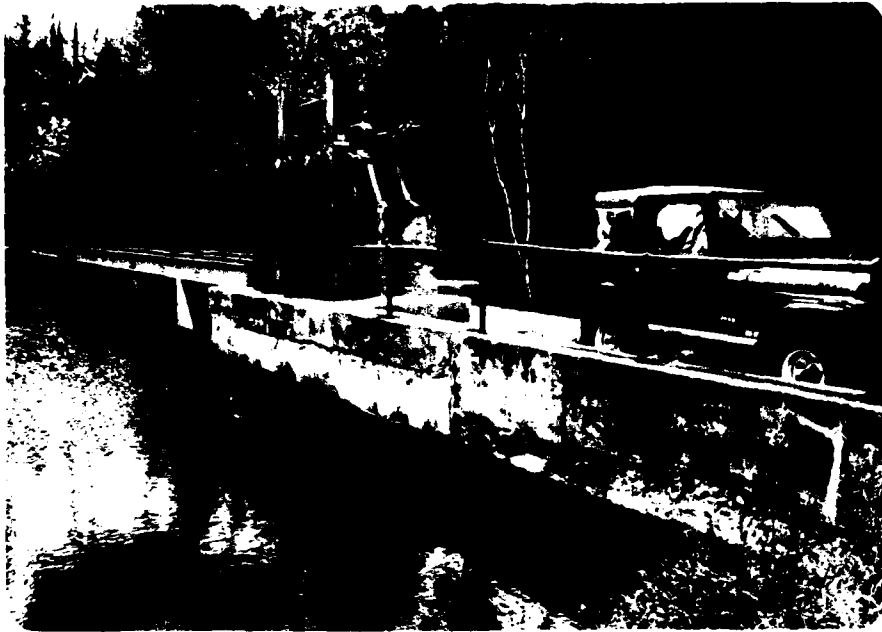
The most obvious deficiency is localized spalling and cracking of the concrete. This was observed on the upstream face of the north retaining wall and outlet headwall (see photo No. 3), on the center pier of the spillway (see photo No. 4), and on the south sidewall of the spillway just downstream of the weir. Slight seepage was observed about midway on the downstream slope below the south retaining wall and next to the spillway sidewall. The seepage appears to be through a vertical crack on the upstream face of the south retaining wall. A significant growth of trees and brush has occurred on the top and downstream slope of the dam below the south retaining wall. The earth fill forming the crest of the dam along the south retaining wall is about 2 feet lower than the top of the wall. Also, a footpath was observed on the downstream slope along the south sidewall of the spillway. The top of the dam along the north retaining wall is clear of trees, and the downstream slope has been filled in to form a parking area.

**NO. 3 SPALLED CONCRETE ON UPSTREAM
FACE OF NORTH RETAINING WALL**

- a. Operating and Maintenance Procedures. It is recommended that the Owner accomplish the following:
 - (1) Repair spalled and/or cracked concrete on the upstream face of the dam, on the center pier and south sidewall of the spillway, and on the upstream headwall and sidewalls of the outlet.

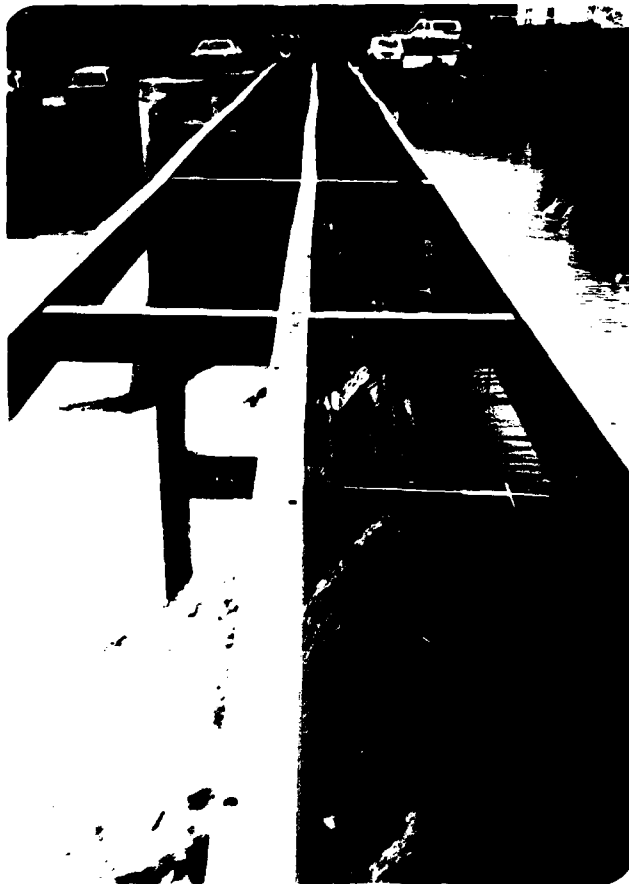
NO. 5 CREST OF SPILLWAY

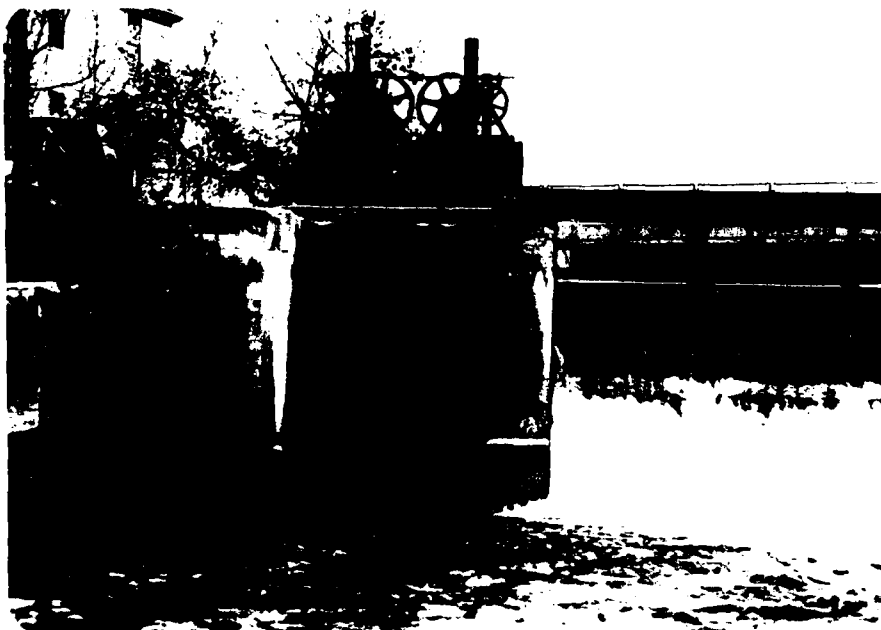
NO. 6 OUTLET GATE
